THE QUITO, ECUADOR, EARTHQUAKE RISK MANAGEMENT PROJECT

AN OVERVIEW

May 1994

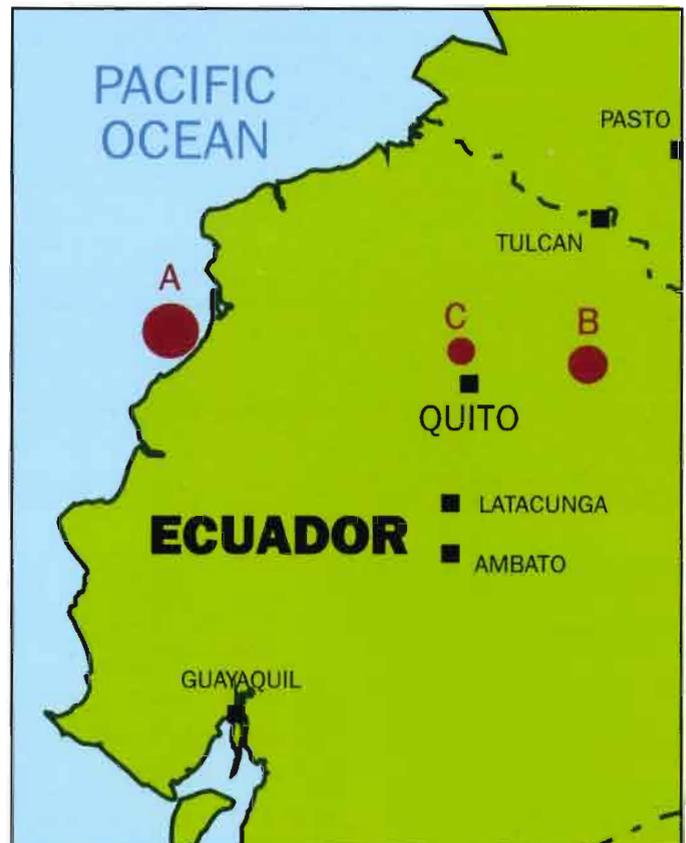
Figure 3. Location of the potential coastal (A), inland (B), and local (C) earthquakes with respect to Quito.

Geologists and seismologists attempted to determine the magnitude and location of earthquakes that would likely damage Quito in the future. They analyzed Ecuador's faults and earthquake records dating back to the 16th century. Three earthquakes, representing the range of possible magnitudes and distances, were selected for detailed assessment (Figure 3):

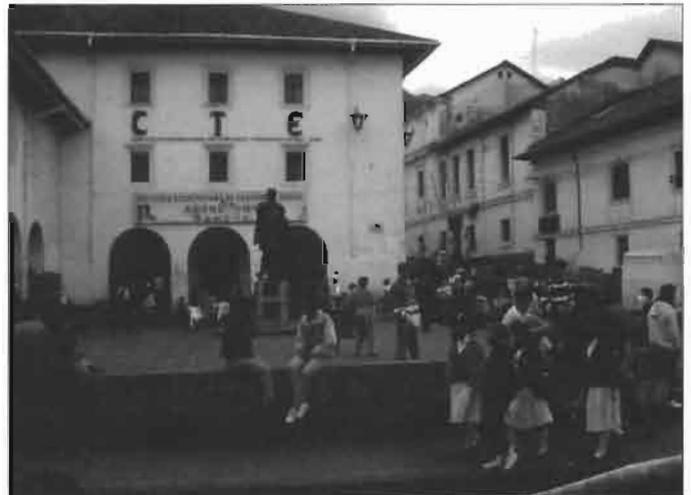
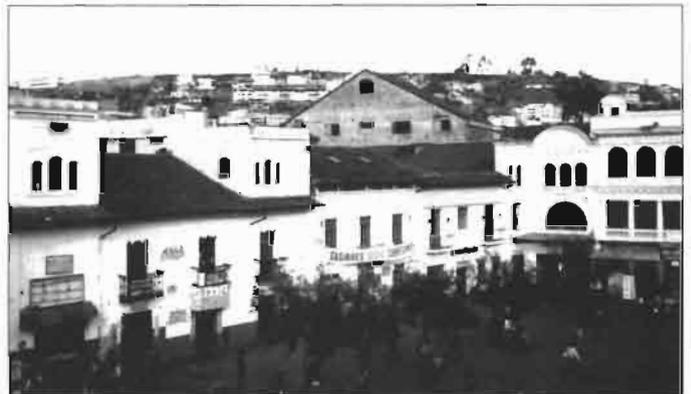
Adobe buildings in the Centro Historico.

the city, many of which are also self-built, would experience significant damage as well. High levels of damage would occur in the Centro Historico, the oldest part of the city, primarily because of the preponderance of adobe and unreinforced masonry buildings. Reinforced concrete buildings would suffer less damage for the same level of shaking.

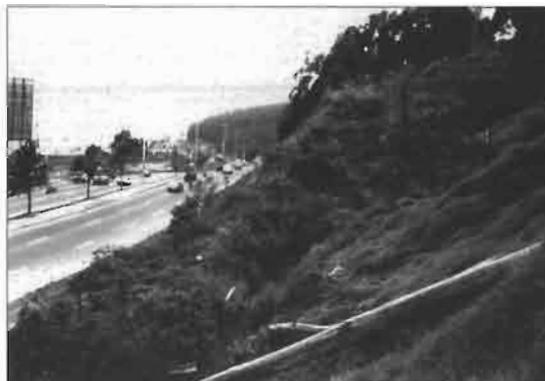
Slopes susceptible to landslides along Via Occidental.

Landslides block Via Oriental and Via Occidental, especially in lanes next to cut slopes. Northern access to the city is interrupted by landslides on Panamericana Norte, the road to the Mitad del Mundo, and the road through Calacali to the coast. Several large landslides and rocks fall on the Tabacundo Highway and Via Interoceanica, making them impassable. A bridge on the Panamericana Norte is heavily damaged, rendering it, too, unusable. Several secondary streets in northern Quito suffer cracking. Northwestern neighborhoods such as Jaime Roldos, Pisuli, and Comite del Pueblo 2 become isolated. Some roads in the northeast are partially blocked; slope failure at the Zambiza garbage dump cuts the only access to that area. Several main north-south avenues are blocked by damaged overpasses. Some motorists, unable to proceed, abandon their cars in the middle of the street. More than a hundred obstructions in the roads of Quito make transit within the city and between northern, central, and southern Quito almost impossible.

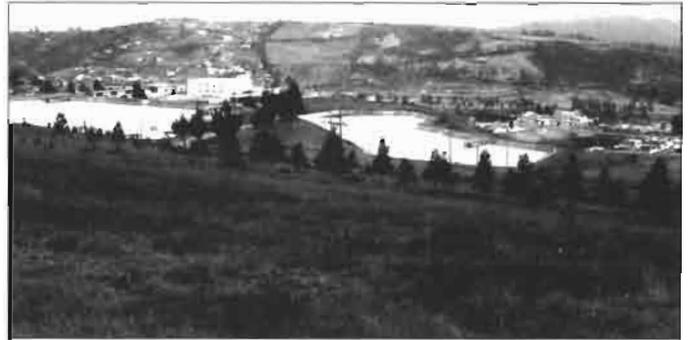
Puengasi water treatment plant.

Water pipes throughout Quito break, especially at their rigid joints and in places where they cross filled quebradas. Landslides block the open canal that brings drinking water to the Puengasi water treatment plant. Some main sewer collectors—in particular, those located on the western slopes of the city—rupture, damaging buildings and streets above. Landslides along the Machangara River block sewage outlets. Structural damage to the central telephone building results in partial loss of telephone communication within Quito and to the outside world. Power poles fall throughout the city, and more than 500 transformers are damaged. Several distribution substations and transmission cables, especially those in the northern part of the city, are seriously damaged, plunging most of

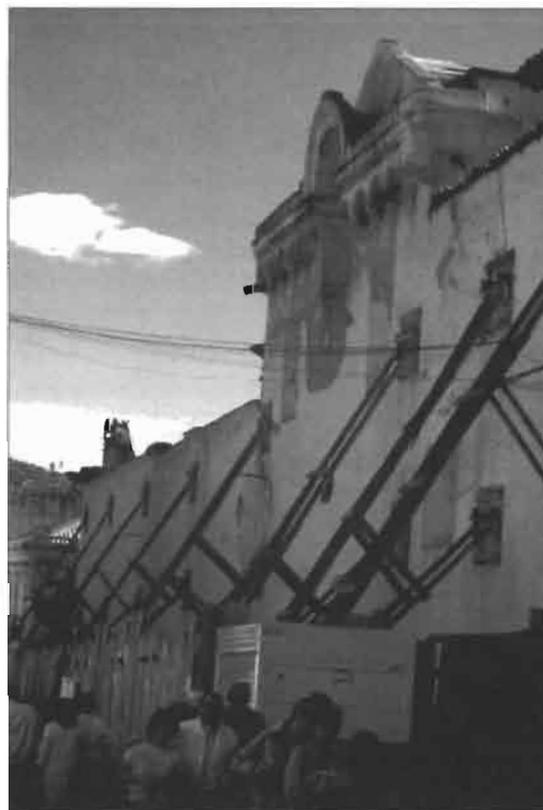
Adobe buildings damaged in the March 1987 earthquake.

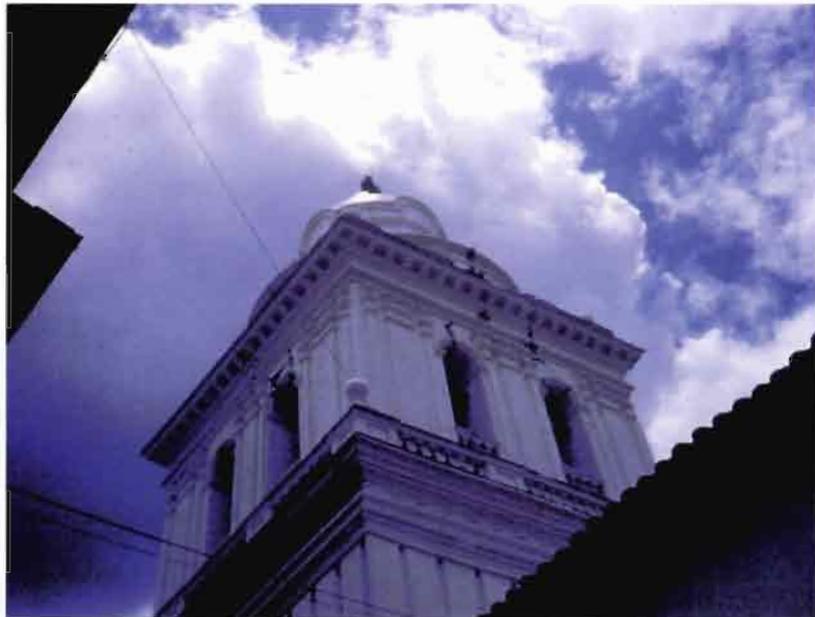
Tile roof and adobe cupola in the Centro Historico.
