Geothermal System as the Cause of the 1979 Landslide Tsunami in Lembata Island, Indonesia

YUDHICARA^{1,2}, PHILLIPSON BANI^{1,3}, and ALWIN DARMAWAN¹

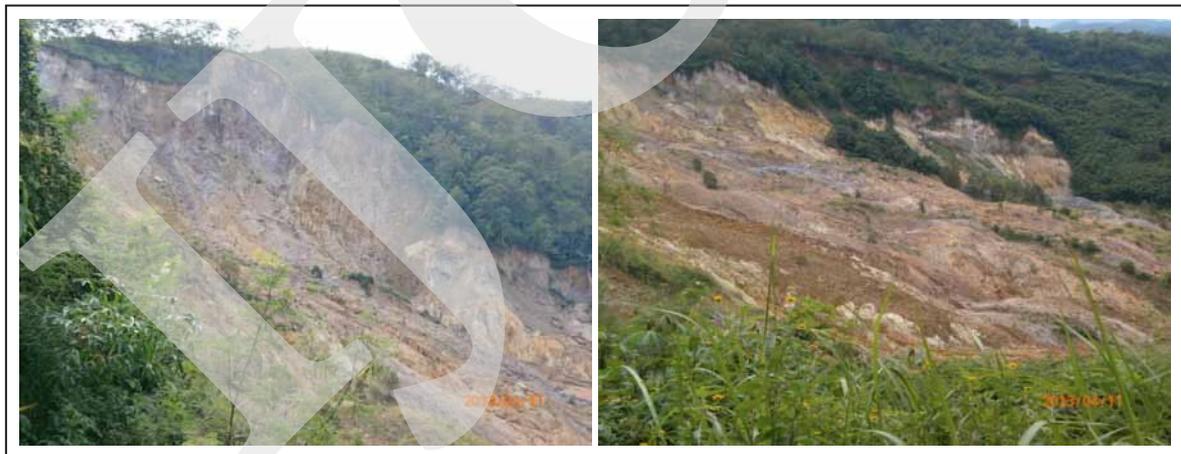
Figure 5. Evidences of the 1979 landslide taken on April 2013, the crown (left) and the landslide body (right) (Yudhicara *et al.*, 2013).

The landslide area is located at an old crater of Iliwerung complex. The crown of landslide is found at Atakore Village, named Bauraja Hill (Figure 5). The Bauraja Hill forms a cliff that is

unstable and prone to landslide, particularly after a heavy rain. The study area is about 1.2 square km. It has many volcanic cones around and close to the landslide site, active faults cutting across it and is often subjected to a heavy rainfall. The study area has a hilly morphology with a very steep slope and is covered by dense forest and

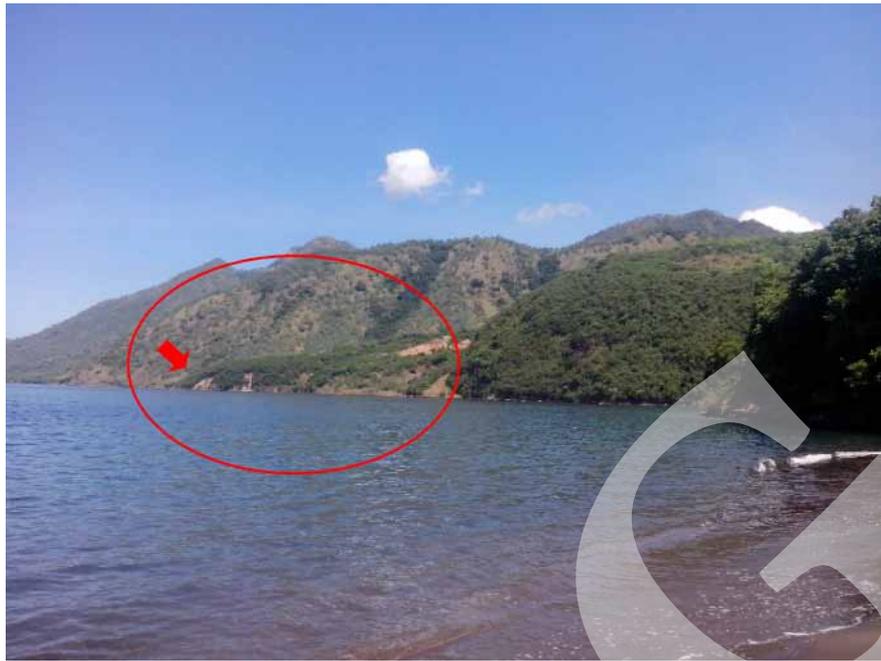
Figure 6. The landslide product protrudes into the sea (red circle); location of water sample is shown by red arrow (Yudhicara *et al.*, 2013).

material was taken nearby the sea (Figure 6), which has finer grain volcanic ashes, yellow to white colour, very soft, clayey, loose, slippery and easy to move.

Some hot springs were found around the landslide site indicating a fumarole system. A water sample was taken from a hot spring at the foot hill of the landslide material at position of 08°28'44"S - 123°33'34.3"E (Figure 6), which coincides with a fault line. The mixing of water
