Master's Thesis
TVVR 10/5005

Changes in the Course of the River Komadugu Yobe during the 20th Century at the Border between Niger and Nigeria

Jenny Martinsson

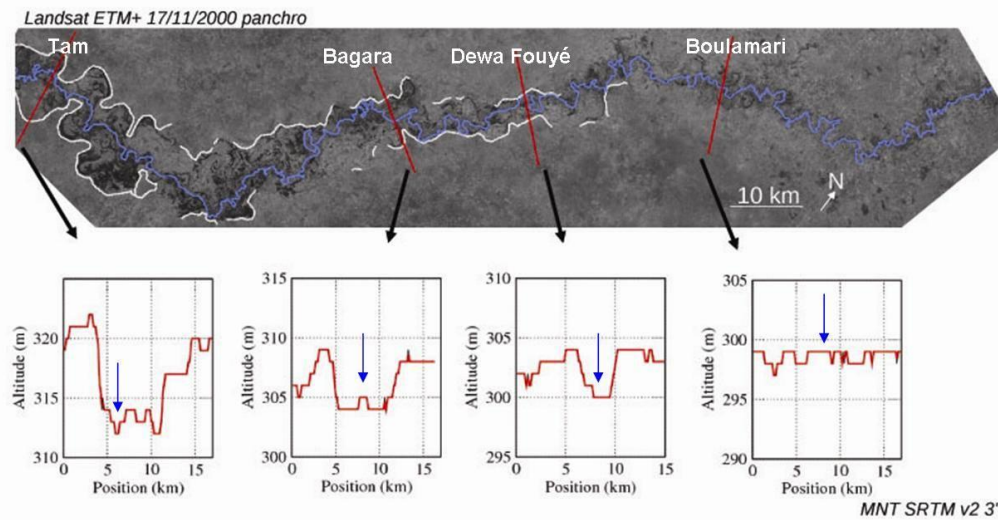
Figure 1.7. The changes in the cross-section of the Komadugu Yobe valley upstream to downstream. The blue arrows indicate the approximate position of the river's channel (revised from Le Coz, 2009).

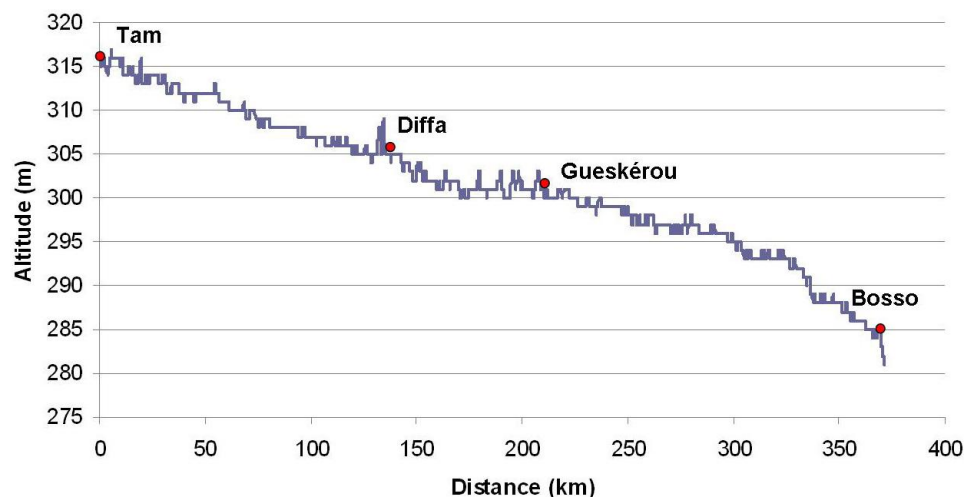
Figure 1.8. The slope of the riverbed from Tam to Bosso (Revised from Le Coz, 2009).

Figure 1.8 shows the slope of the riverbed upstream to downstream. The altitude is measured from a 3" SRTM DEM (Shuttle Radar Topography Mission, Digital Elevation Model) which has an approximate resolution of 90 meters.

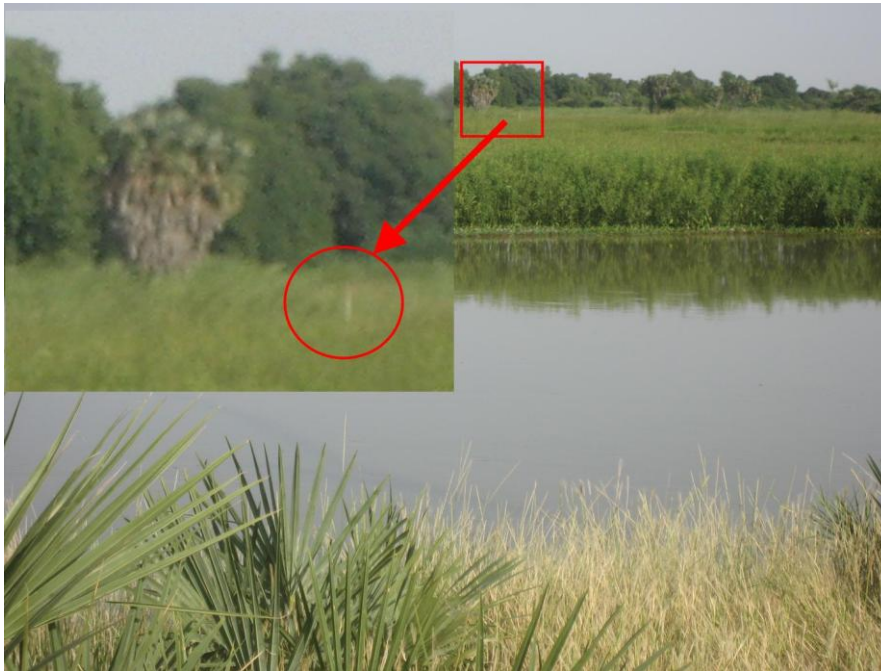
Figure 3.5. Photo of old beacon 148, October 2009.

It was sometimes difficult to interpret what the villagers meant. Concerning beacon 148 at Tam, the villagers said that the present beacon has been there for three years and that the old one was replaced by the military in 2004. It was then moved six meters to the north. They are also mentioning that the replacement of the old beacon was done by the commission of the delimitation of the border.

The two different beacons have been seen on the field and it is verified that there are two. However, it is not a distance of six meters between them. The distance is approximately 300-500 meters. The interpretation of this is that the old beacon was first replaced in 2004 and moved six meters to the north. Then, in 2006, another new beacon was put into place and it is this one which now marks border.

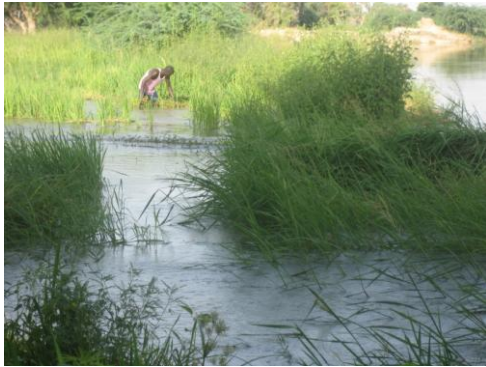
Figure 3.8. Inflow to the oxbow lake “Walou Minam”, October 2009.

opposite side of the border. The problem the villagers in Tam meant is probably connected to fishing. Today they can fish in the whole oxbow lake. If the river connects to it, they would only have the right to fish on their half. During the time of the visit, there was water flowing into the oxbow lake (fig. 3.8).

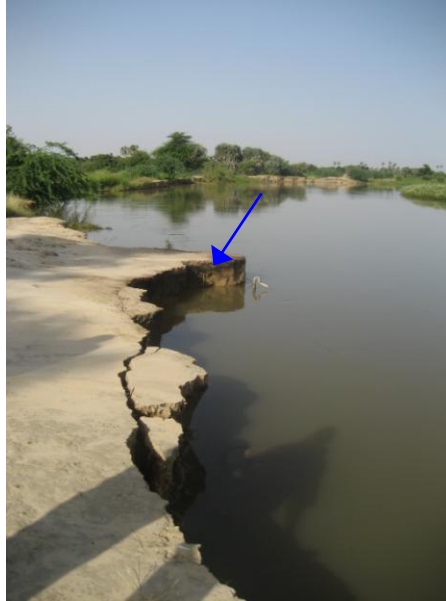
Figure 3.9. Photo showing erosion on the banks and ash traces at the tip of the arrow from the old settlement of Baradi, October 2009.

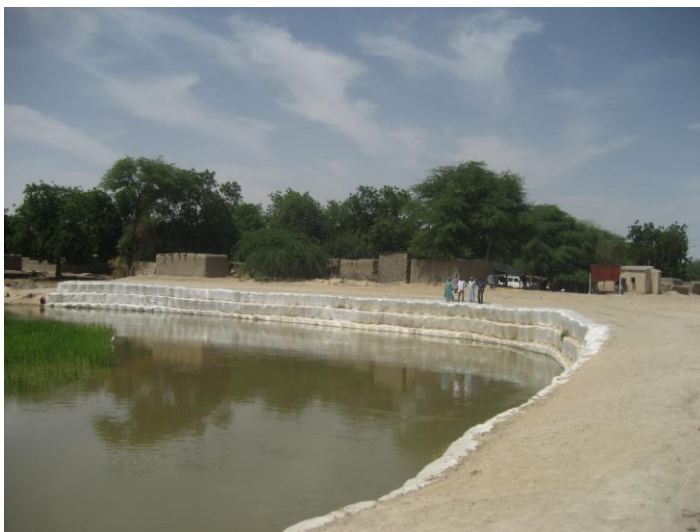
Figure 3.10. Reinforcement of the banks of the meander, by the local organization PADL, at Bosso.

The erosion is threatening numerous villages and houses along the river. In Bosso, the erosion on the meander is threatening the village and official buildings. The banks have been reinforced in 2009 by the local organization PADL (fig. 3.10).
