PRELIMINARY RESULTS

CONCLUSIONS

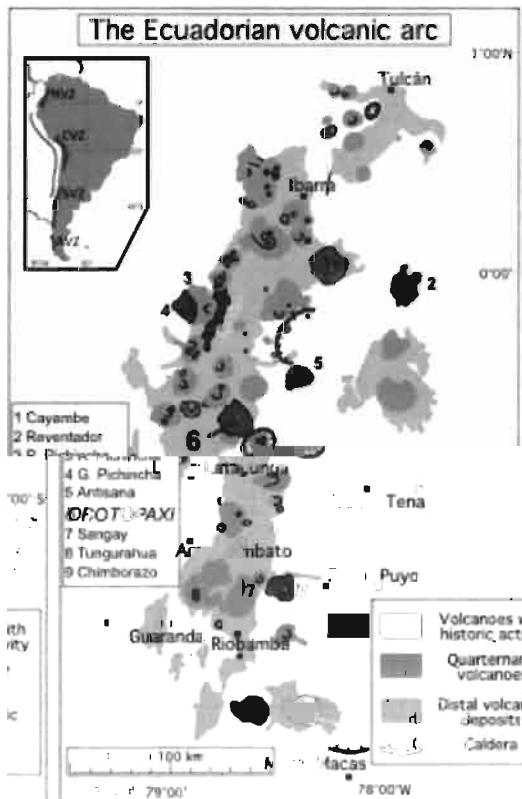
Fig. 1 (at the left side): Localisation of the Cotopaxi volcano in the Ecuadorian volcanic arc.

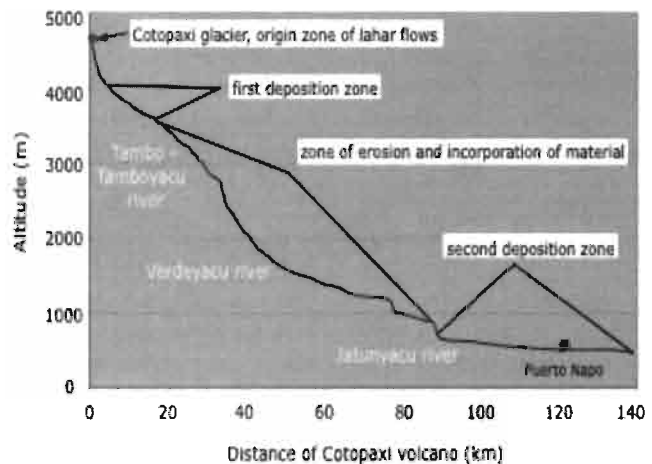
Fig. 2 (down): Longitudinal profile of the Tambo-Tamboyacu river system from its source at Cotopaxi's glaciers downwards to the Amazonian plain, with the succession of two deposition zones separated by an erosion zone.

The lahars of the eastern flanks of the Cotopaxi volcano travelled distances of about 120 km, from the base of the volcano to Puerto Napo. The difference in altitude is about 4200 m, with a mean slope value of 9,06 % (Fig.2). Three quarters of their journey, lahars passed through the rain forest, which implies great possibility of erosion and incorporation of organic debris. The evolution of grain size distribution is from massive coarse-grained debris flow deposits in the Tambo-Tamboyacu area to fine-grained hyperconcentrated stream flow deposits in the Jatunyacu area. The Tambo-Tamboyacu lahar terraces are poorly sorted, mainly normally graded, with a weak fabric (Photo 1).
