Mitigation of water erosion in no tillage systems in the Mediterranean zone of central Chile

Mitigation of water erosion in no tillage systems in the Mediterranean zone of central Chile.

In : Geeson N. (ed.) Focus on research in Chile and Mexico. Newsletter - Desire Project, 2011, (7), p. 6.

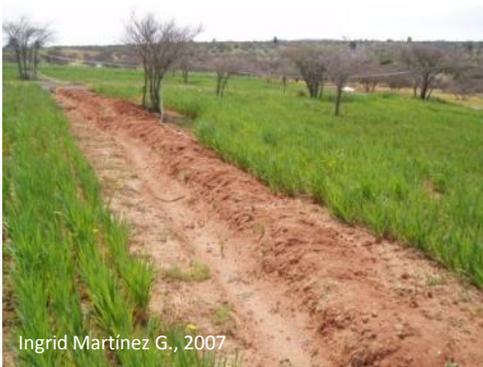
No tillage with contour ploughing in runoff plots of 1000m²

An oat-wheat rotation under different conservation systems: no tillage (Nt), Nt+contour ploughing, Nt+barrier hedge, and Nt+subsoiling were compared to conventional tillage.

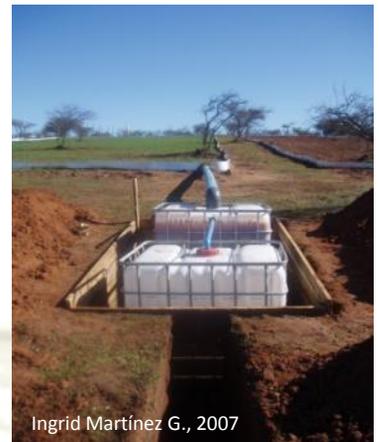
Runoff storage tank

The runoff coefficient during the rainfall period was more than 50% in conventional tillage, while in conservation tillage it was between 20-30% in the first month after sowing, and less than 7% the following months. Reduced runoff is important since soil erosion will also be reduced.
